# TRANSMISSION VARIATIONS

## "EARLY" STANDARDIZED WW2 JEEP T-84J TRANSMISSION

## "MID" STANDARDIZED WW2 JEEP T-84J TRANSMISSION

## "LATE" STANDARDIZED WW2 JEEP T-84J TRANSMISSION

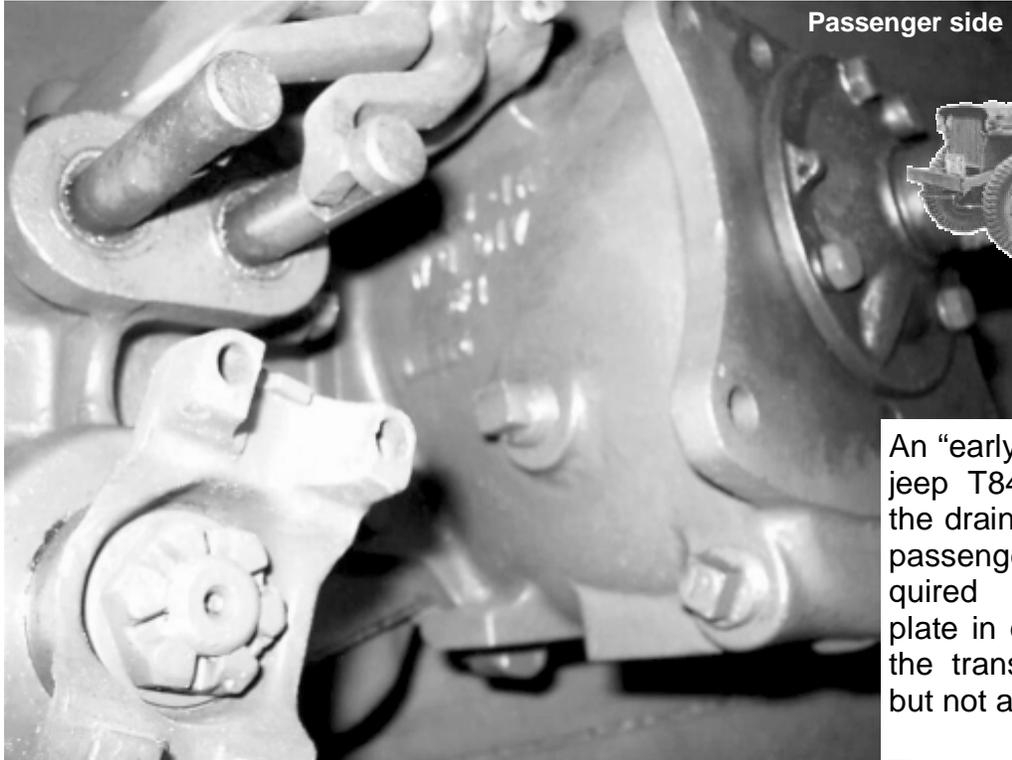
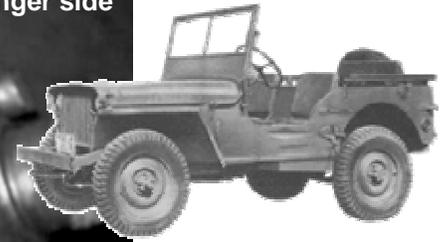
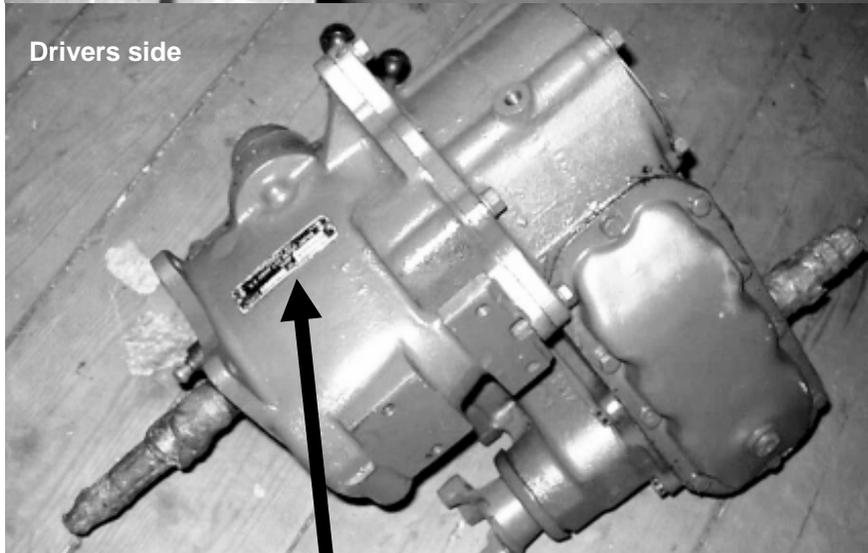
An "early" standardized WW2 jeep T84J transmission had the drain and fill plugs on the passenger side. This required removing the skid plate in order to fully service the transmission. Not hard but not a fun exercise.

The so called early transmission was the norm until 1944. According to Lawrence Nabholz in his, **The Military Jeep**, this transmission was replaced with the "H" style or higher capacity transmission in November 1944.<sup>5</sup> This correlates with the article that was printed in the December 1944 issue of **Army Motors**, see page 16.

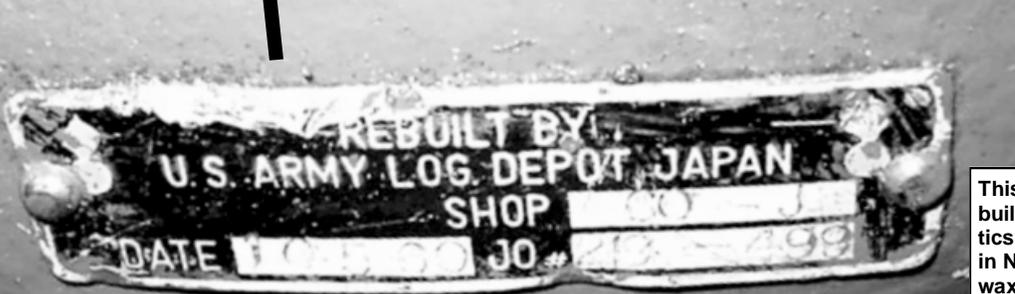
This transmission was rebuilt by the US Army Logistics Depot, Japan and was in NOS condition, note the waxed paper coverings on the shafts.

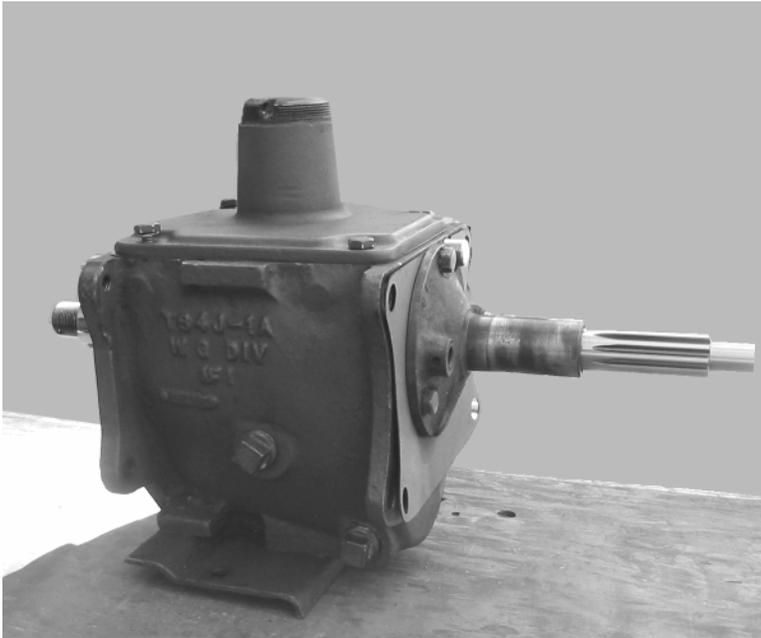
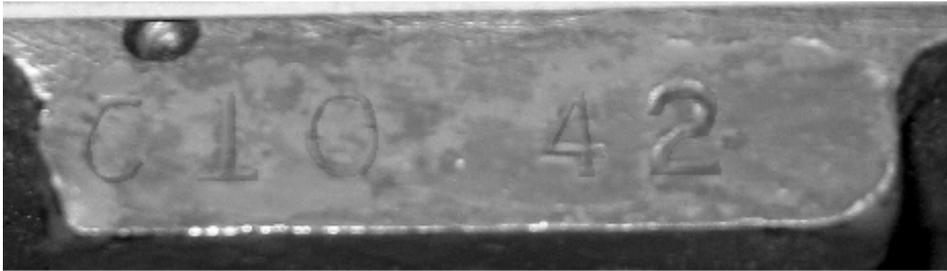
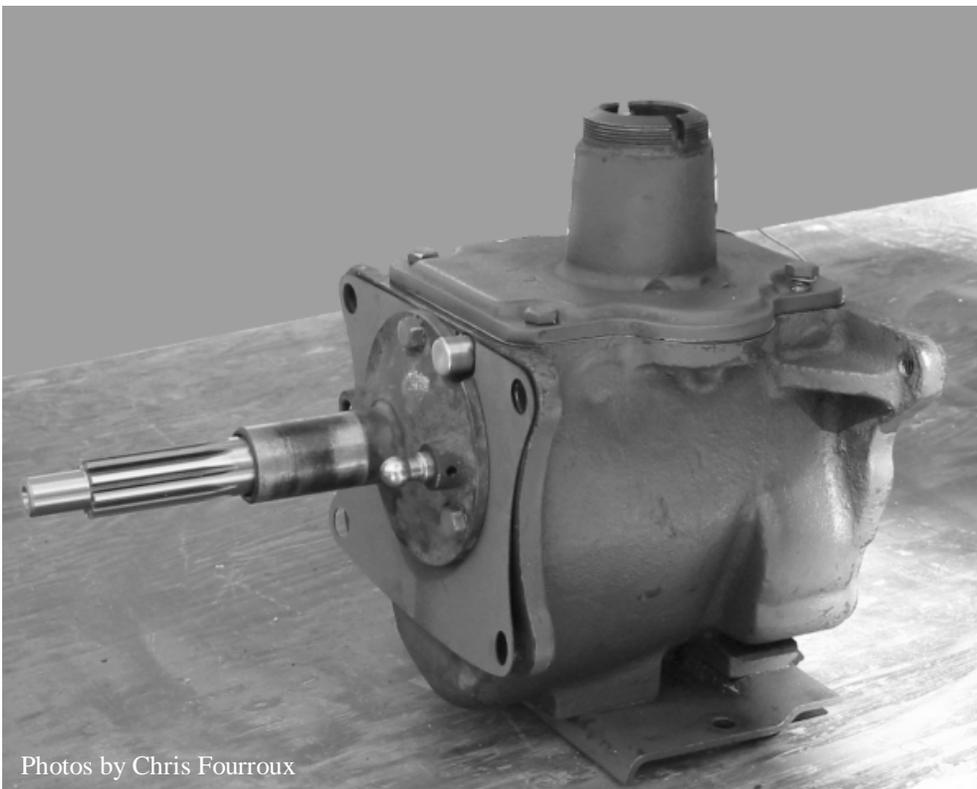
Another example of the “early” MB case. Note the plugs on the passenger side of the case. On the upper “lip” of the transmission case you should be able to find a date code. The code “C 10 42” was on Chris Fourroux’s transmission case (here it was computer enhanced to make it more visible in the print). This is decoded as March 10, 1942 as I understand it.

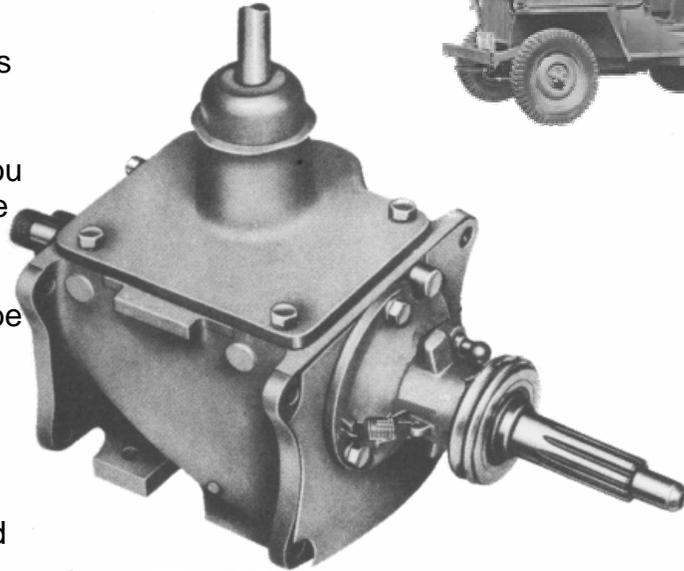
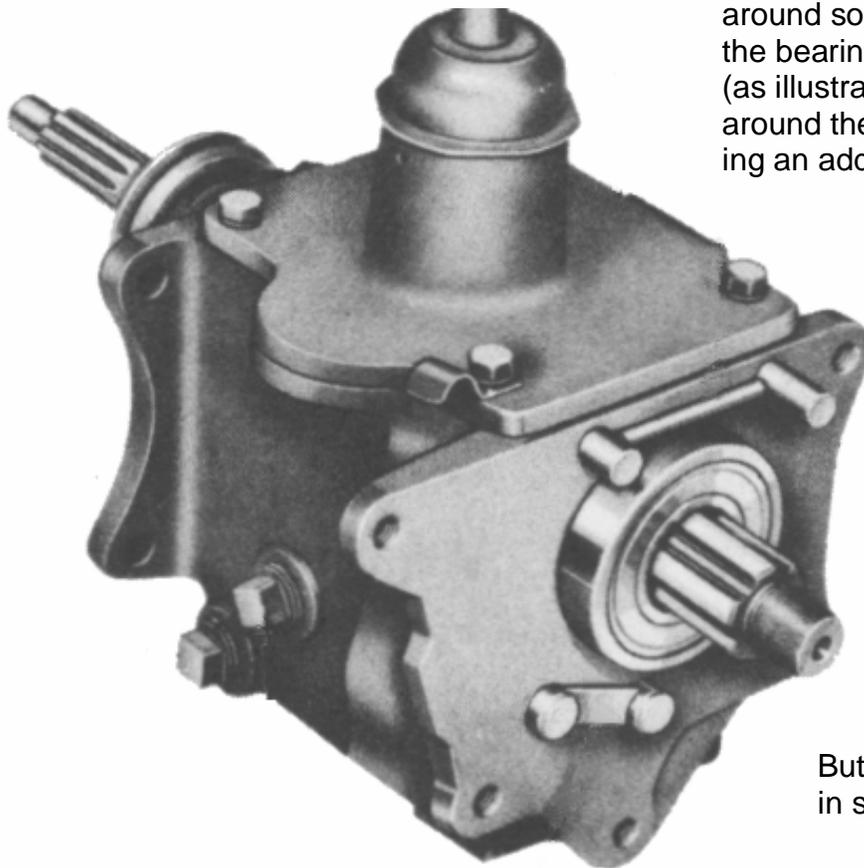
Source: TM 9-1803B

the rear main bearing was turned around so that the sealed side of the bearing faced the transfer case (as illustrated at left). Turning around the seal helped some. Adding an additional slinger helped, too.

This transmission will only hold 3/4 quart of lube. Originally lube would "pump" from the transfer case so

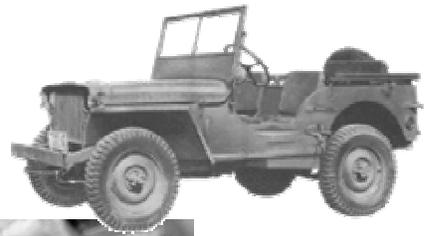
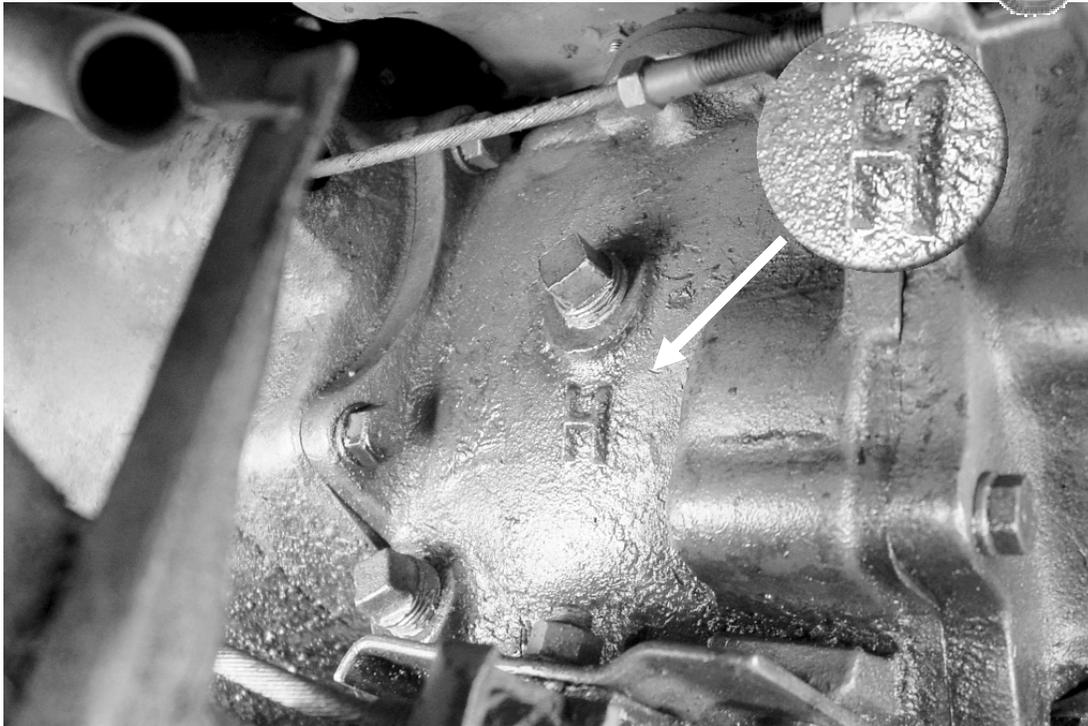
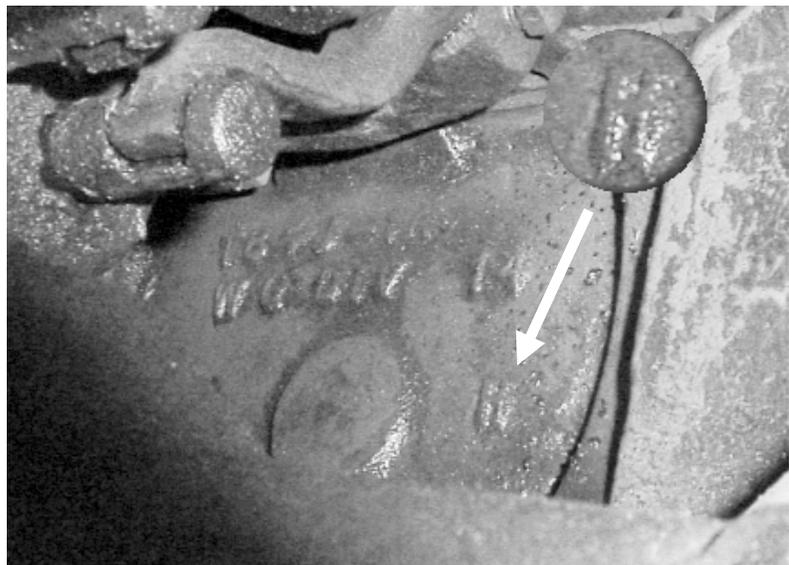
The late standardized 1/4-ton transmission was the T-84J with an "H" embossed on the side of the case. It was introduced into production in late 1944. (November, 1944 according to L. Nabholz.<sup>5</sup>)

The case had a few improvements, the most important was the increased lubricant capacity. The full quart of lubricant increased the cooling capacity—leading to a potentially cooler running transmission—a good thing! Cases marked with the "H" contain one quart of lube. Another improvement was the introduction of a new spacer and a seal. (see page 16) for details.
